SERVICE INFORMATION

LAND-ROVER PETROL AND DIESEL MODELS

Vol. 1 No. 10

December, 1972

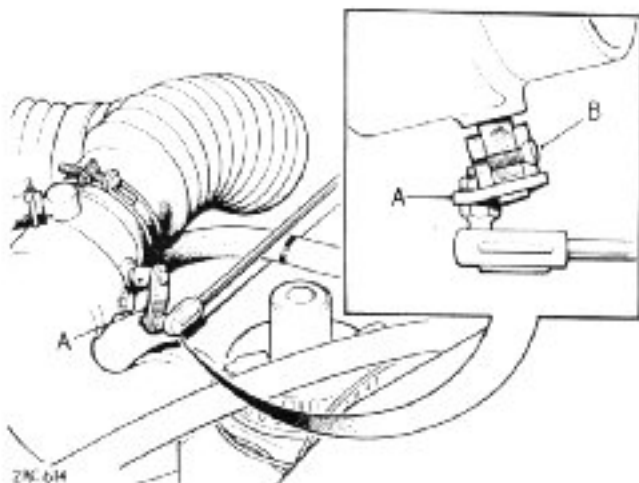
Fig. 1 Inlet manifold butterfly valve

A small number of cases have been reported where the clamp screw, which locks the operating lever to the butterfly valve, has come loose.

If this condition is present on a vehicle, it can cause either a loss of vacuum or excessive smoke to be emitted from the exhaust. Should Distributor or Dealer personnel come across this problem they are advised to first check the positioning and tightness of the clamp screw. If the component is found to be loose it is recommended 'Studlock' or 'Loctite' is applied and the screw re-tightened.

Production Department, as an interim measure, from April, 1972, have been applying 'Studlock' on the screw. To overcome this possible condition permanently, however, it is anticipated that a re-design of the particular area concerned will be carried out.

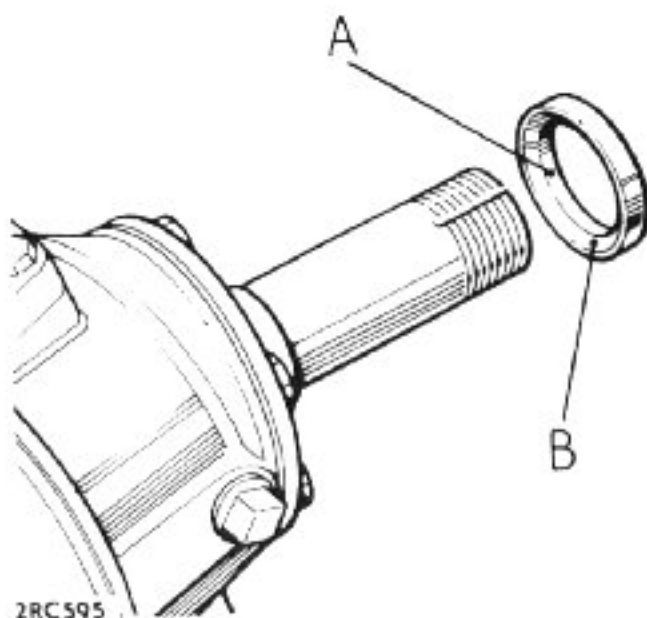
Fig. 2 Distance piece for inner hub bearing

A number of Land-Rover owners have experienced hub oil leaks which, in most cases, may be attributed to the sintered iron type inner bearing distance piece, Part No. 217351. This may be subject to splitting in service and cases of porosity have been reported, believed to be due to surface cracking.

A—Apply Bostik 772 to inner circumference
 B—Apply Bostik 772 to tapered surface

Where hub oil leaks are due to this condition the inner bearing distance piece can be removed as described in the appropriate manual operation listed above and replaced with the latest mild steel type, Part No. 599698, ensuring that Bostick 772 is applied liberally to the inner circumference and the tapered surface which faces the back plate.

In this case, it is recommended that, by exercising reasonable care the distance piece can be partially cut through with a sharp chisel to loosen it, when it can be gently prised off.

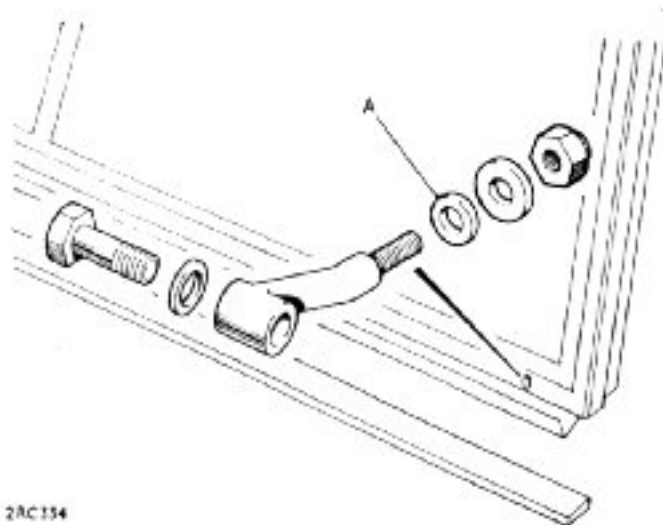
Fig. 3 Windscreen pivot arm fixings

REMARKS: In certain instances the fibre washer between the windscreen and the pivot arm cracks after initial tightening and during service this washer is displaced by vibration, thereby allowing movement between the windscreen assembly and the windscreen pivot arm. The eventual consequences of this condition is a cracked or broken windscreen pivot arm. The fibre washer has now been replaced by a copper washer and this should be used for all replacements.

A—Copper washer
