The Rover Company Limited, Solihull,
Warwickshire, England

June, 1972

INDEX

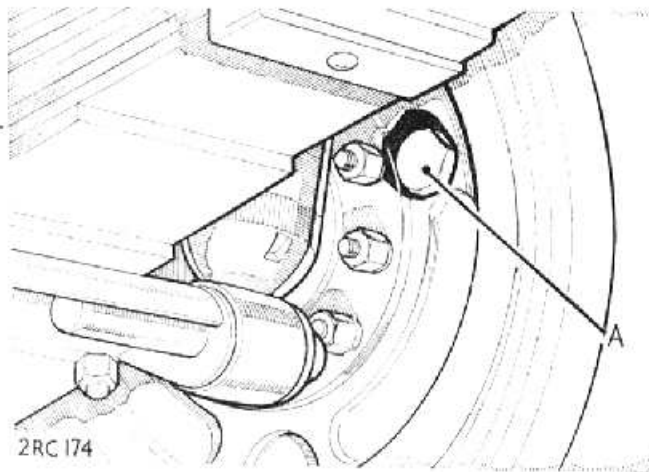
Fig. 1 Wheel brake adjustment

REMARKS: If low brake pedal is a problem in Service it has been found that an improvement can invariably be made by carrying out the simple adjustment procedure to the **rear brakes** as detailed below.

1. Raise the rear of the vehicle and place on stands.
2. Ensure the rear wheels turn freely.
3. With the foot brake firmly applied adjust **one** snail cam to its maximum position.
4. With the foot brake released, undo the cam one or two notches until the wheel just turns freely.
5. Repeat operations 3 and 4 on the remaining rear brake shoe snail adjuster.
6. Check the brakes for correct operation.
7. Lower the vehicle to the ground.

This operation centralizes the brake shoes to the drum without putting any excessive strain on the snail adjusters which could result in damage.
