SERVICE INFORMATION

LAND-ROVER PETROL AND DIESEL MODELS

Vol. 1 No. 6

August, 1972

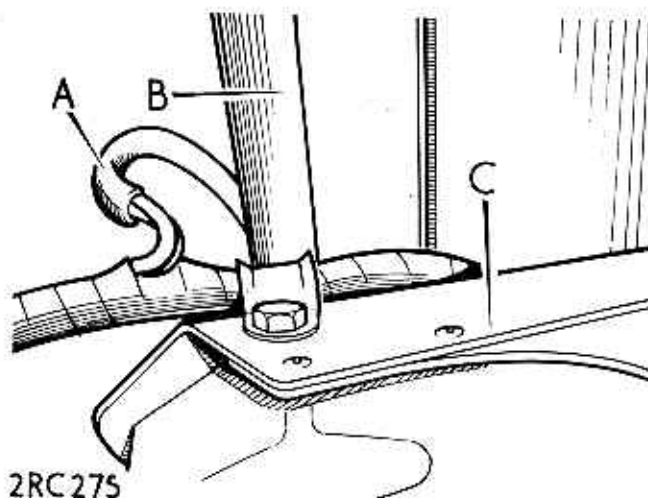
Fig. 1 Correct location of solenoid feed wire

A—Solenoid feed wire
B—Air cleaner
C—Wing valance

It has been brought to our attention that in certain instances a 'foul' condition may be present between the air cleaner, main harness assembly and the right hand side wing valance.

Service personnel are requested to examine all earlier vehicles, during routine maintenance checks and, if required, peel back the non-adhesive harness binding tape, thus allowing the solenoid feed wire to be re-routed away from the obstruction.

Should the solenoid feed wire be badly chafed, it should be replaced with the modified main harness assembly.

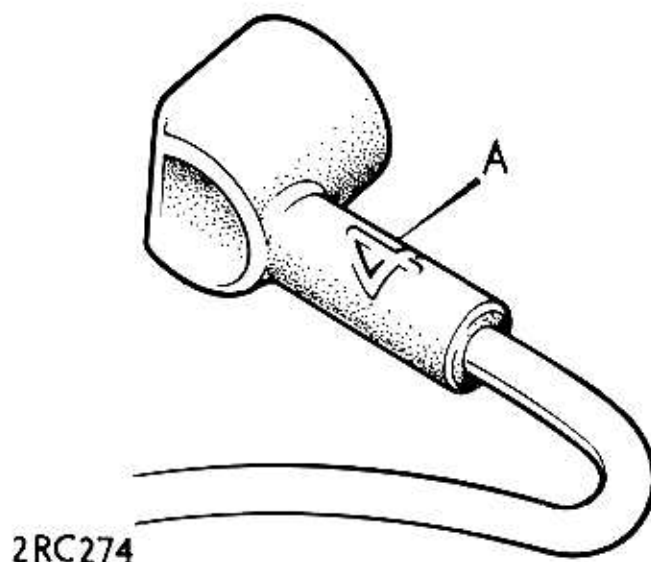
Several cases of engine misfire, and poor starting under wet or damp conditions have been reported and investigation has shown this to be caused by poor moulding of the right angled coil boot on the coil to distributor high tension ignition lead.

Fig. 2 Identification of ignition lead

A—Moulding number

If this condition is detected or brought to your attention by an owner, on vehicles sold during the last 12 months, then the coil to ignition lead must be changed for the modified type, which has a moulding number stamped on the right angled coil boot. The earlier type has no moulding number.
