# SERVICE INFORMATION

Vol. 1 No. 8

# LAND-ROVER PETROL AND DIESEL MODELS

October, 1972

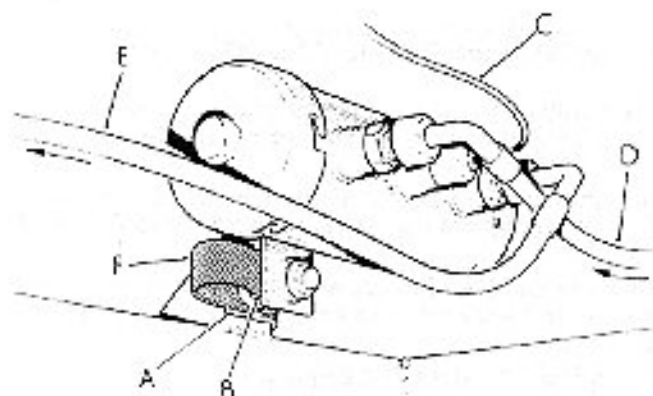
Fig. 1 Fuel pump installation

MODIFICATION: Introduction of Bendix electric fuel pump, replacing the S U fuel pump previously used, to overcome problems of corrosion.

The Bendix fuel pump is being fitted to current Land-Rover 109 vehicles with 2.6 litre engine.

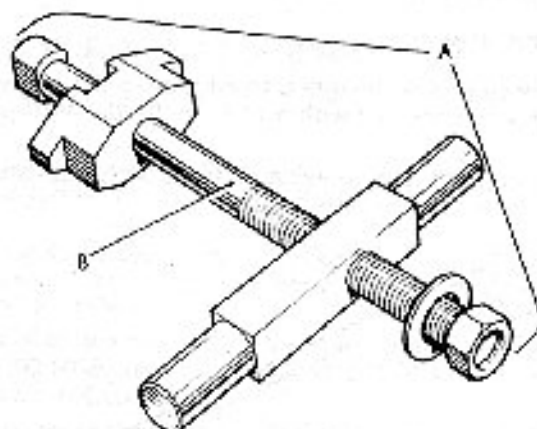
**Fig. 2** Removal tool for pinion head bearing

On all Series III models and at the vehicle suffix letter change from 'G' to 'H' on Series IIA models, the pinion oil seal retainer is integral with the differential casing and not removable as previously; therefore a longer centre bolt has been provided for the Service tool used to remove and refit the pinion head bearing cup, to cater for the extra depth of casing involved.

Lengthening the centre bolt has resulted in a tool number change from 262757 (which remains suitable for early models) to 262757A which is suitable for both early and late models. The longer centre bolt is available separately under Part No. 262757A detail 3 to enable holders to modify their original tool Part No. 262757 which is then suitable for both early and late models.

A—Tool 262757A complete

B—If required centre bolt only obtainable separately under Part Number 262757A detail 3

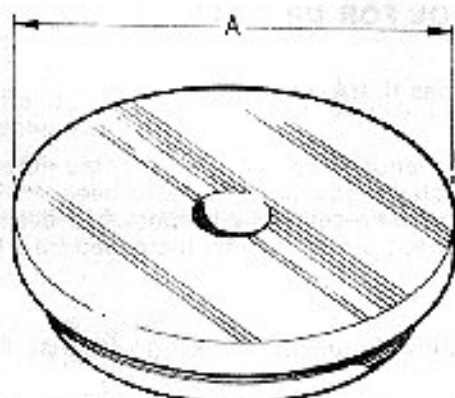
Fig. 3 Press block for pinion head bearing

In conjunction with the above modification, the opportunity has been taken to provide a new press block which gives a greater contact area with the pinion bearing cup. The new press block Part No. 262757-1 replaces the earlier press block Part No. 262758 for the following models:

A—Early tool Part No. 262758 measures 69 mm (2.7 in.).  
Later tool Part No. 262757-1 measures 77 mm (3.0 in.)

Land Rover Series IIA with axle serial numbers from Suffix 'B' onwards, and all Land Rover Series III models.

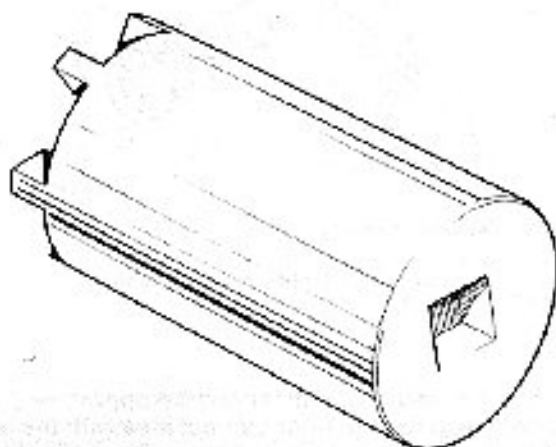
Fig. 4 Spanner for stub shaft nut

MODIFICATION: Introduction of a Service tool for removing/refitting the circular castle nut which retains the front hub driving member and the axle stub shaft.

REMARKS: The above Service tool is designed to engage in the castellations of the circular castle nut. The free end is provided with a 12.7 mm (0.500 in.) square hole to accept a suitable wrench.
